the Fate of U-869 REEXAMINED

Part II of a 3-Part Article
The U-Boat War

The Crow/Koiner Incident

By Richie Kohler, John Chatterton and John Yurga

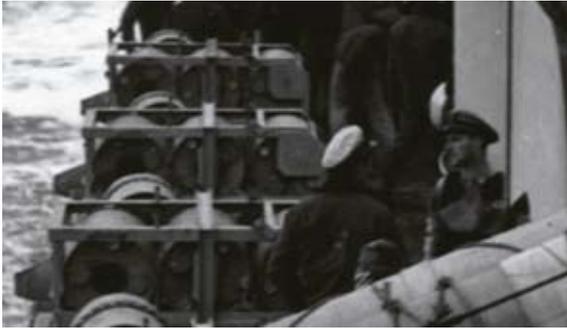
Depth charges in position on the *Howard D. Crow*.
(National Archives)

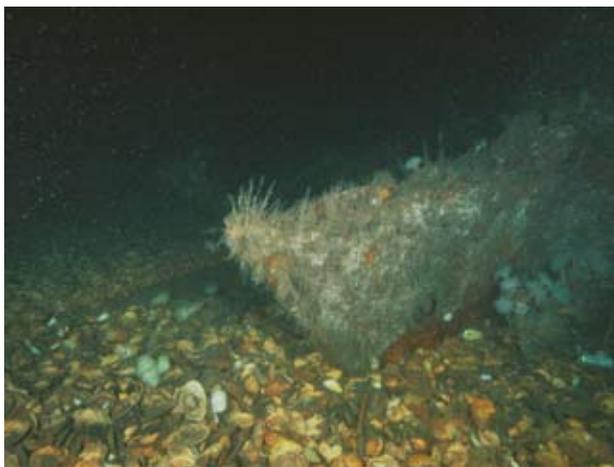
Below: The tip of the bow of *U-869* is half buried in the sand, the two lower torpedo tube doors covered. The upper section has recently been torn off by a dragger trawl, and is over 50 feet away from the wreck. (Photograph by Richie Kohler)

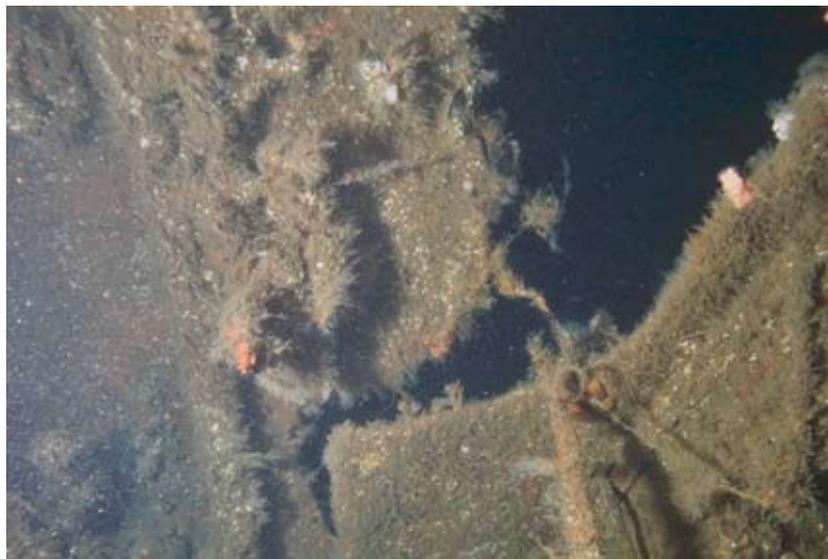
EVIDENCE OF DAMAGE.
 (a) Large quantities of oil, wood, articles of uniform, inflatable life rafts, and miscellaneous debris from both interior and exterior of the submarine following *ATHERTON's* fourth attack. (Each subsequent attack brought additional oil and debris to the surface.) Diving operations were carried out and the target determined to be a German submarine, which had been "killed" but a short time before.

EVIDENCE OF DAMAGE.
 (a) Large quantities of oil, wood, articles of uniform, inflatable life rafts, and miscellaneous debris from both interior and exterior of the submarine following *ATHERTON's* fourth attack. (Each subsequent attack brought additional oil and debris to the surface.) Diving operations were carried out and the target determined to be a German submarine, which had been "killed" but a short time before.

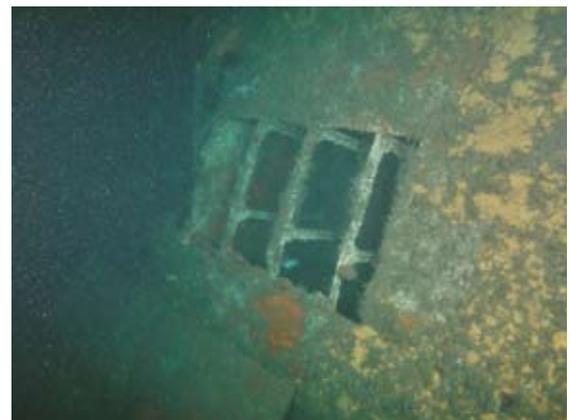
As seawater continues to deteriorate the steel of *U-869*, entire sections of the plating fall off of the streamlined outer hull. (Photograph by Richie Kohler)

The direction and type of fractures in the upper section of the pressure hull above the diesel motor room or *U-869* indicate stresses from an internal explosion, not depth charge damage. (Photograph by Richie Kohler)

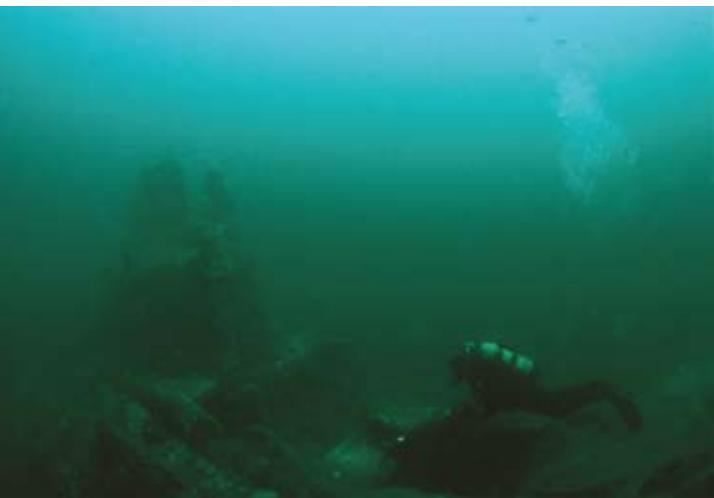
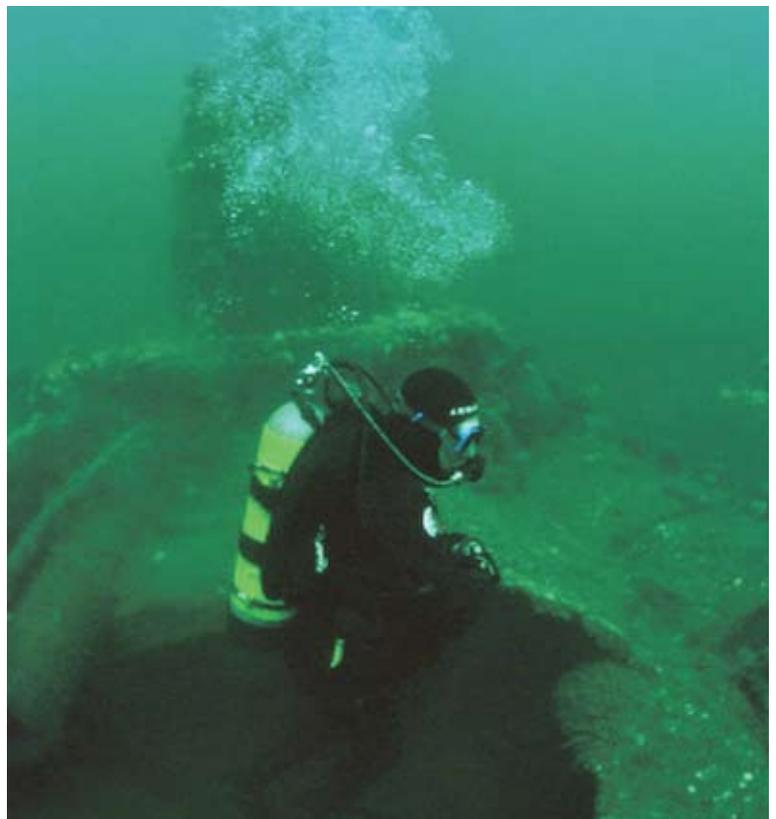
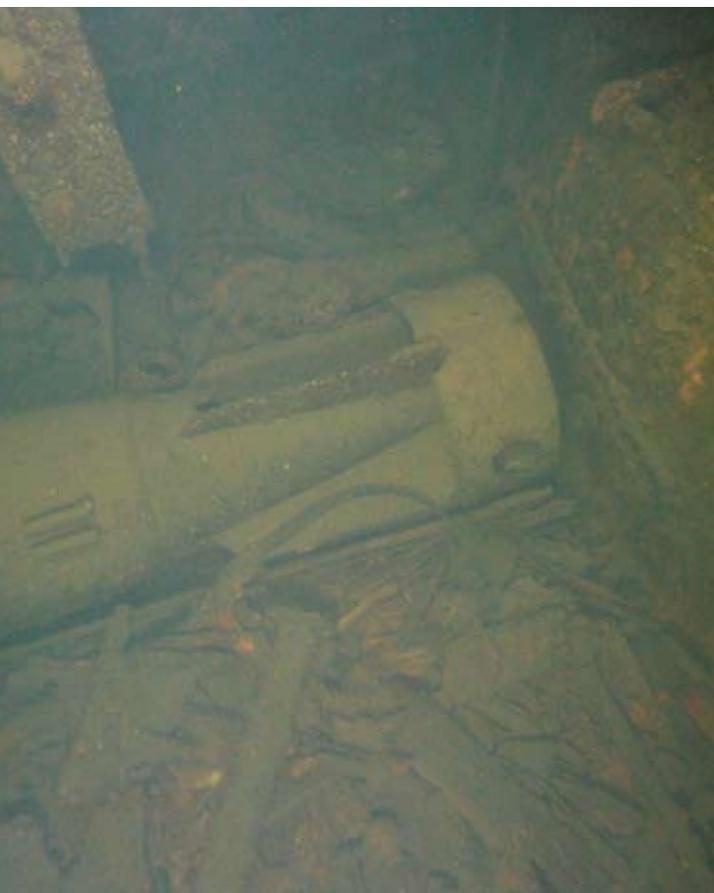
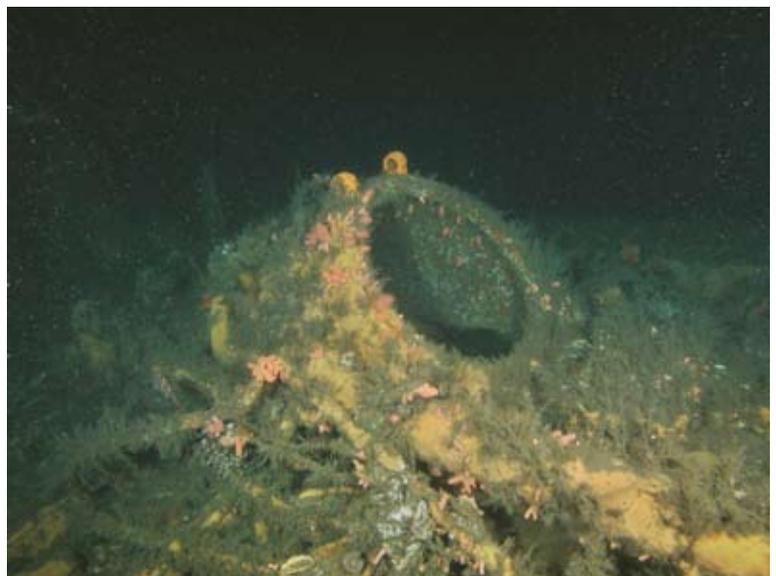
Top left & right: Photographs of *U-853* portray the inward bending of the pressure hull's metal caused by depth charges or hedgehogs from the outside. (Photographs by James Lee)

Bottom left: Peering down the hatch of *U-869*, a spare torpedo is seen on the starboard side deck, a protective shroud covering the propeller. (Photograph by Richie Kohler)

Bottom right: The unique angular hatch combing of *U-869* was our first clue the wreck was not a barge but a submarine! Note: this hatch (like all the others on the sub), has been blown off its hinges. (Photograph by Richie Kohler)

There are two distinctly different areas of damage to *U-869*: the control room and the aft torpedo room. The damage in the aft torpedo room appears similar to depth charge damage noted on other U-boats, such as *U-853*, which was built at the same shipyard as *U-869*. The attack on *U-853* is a well-documented sinking by surface vessels using depth charges. There is an area aft on *U-869* where the pressure hull is compromised and pushed inward, obviously from an explosive force from outside the vessel. This is significant damage and a major breach in the pressure hull directly at the aft torpedo room loading hatch, and slightly aft. This damage is similar in character to what can be seen on *U-853*.

In the area of the control room, the damage is different and far more severe. The pressure hull itself is completely destroyed on the port side, from the sand level all the way over, across the top, to the starboard side. This damage area runs more than 20 feet, from the forward control room bulkhead, to the aft control room bulkhead, and beyond. Cracks in the pressure hull extend both forward and aft. The conning tower, which was atop the control room, is adjacent to the port side of the wreck and only connected to the main body of wreckage by little more than a periscope. The starboard side pressure hull in the control room area has multiple fractures. This boat is virtually blown in two, amidships.

Aside from being so severe, the damage around the control room is characteristically different from the damage in the aft torpedo room, as well as any damage observed on any submarine the writers of this article can recall. The damaged pressure hull around both control room bulkheads is actually deflected out, not in. The pressure hull around both of these control room bulkheads is significantly separated from the bulkhead itself in areas, and on the port side forward this separation is close to three feet.

When the wreck was discovered, all of the pressure hull hatches were found to be blown open or completely off, from the forward torpedo room to the aft torpedo room, including the conning tower.

As already stated, the damage in the area of the control room is catastrophic. According to explosive experts consulted by the authors, the steel of the pressure hull being bent outward, as opposed to being pushed inward, tells us a few things.

The first is that the damage occurred while the submarine pressure hull was filled with a compressible medium, which would have to be air, not water. This is also indicated by all the pressure hull hatches being blown open or off. The hatches are designed to take pressure from the outside/in with the only thing other than the water pressure holding the hatches down being several “dogs.” They were never meant to take a reverse pressure differential, with inside pressure greater than outside. This indicates that a tremendous concussive wave affected the submarine from the bow to the stern with enough pressure inside to cause the “dogs” to fail, and the hatches to blow open. Depth charges on *U-853* did not blow open any hatches.

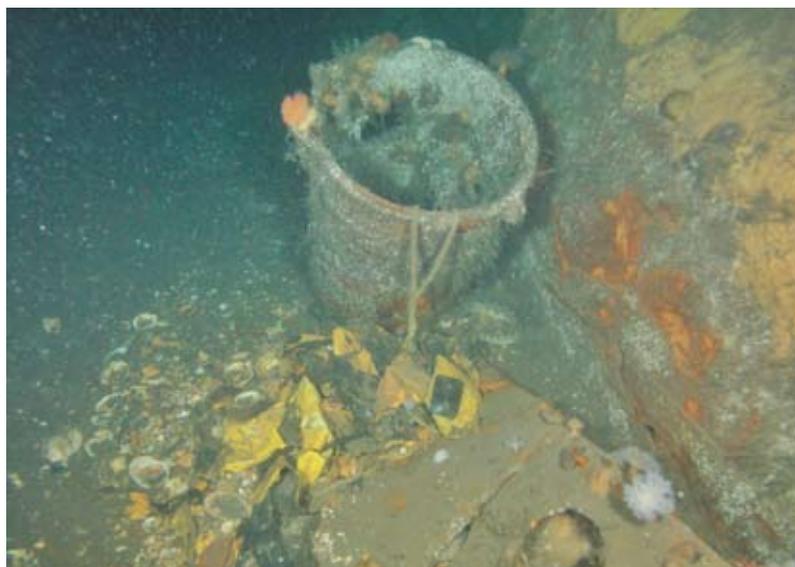
Left: An emergency life raft canister of U-869 that once sat on the upper deck now lays adjacent to the hull on the port side, a tattered life raft hanging out. (Photograph by Richie Kohler)
