The Fate Of The U-869 Reexamined, Part III

The Loss of the German Submarine

By John Chatterton, Richie Kohler, and John Yurga

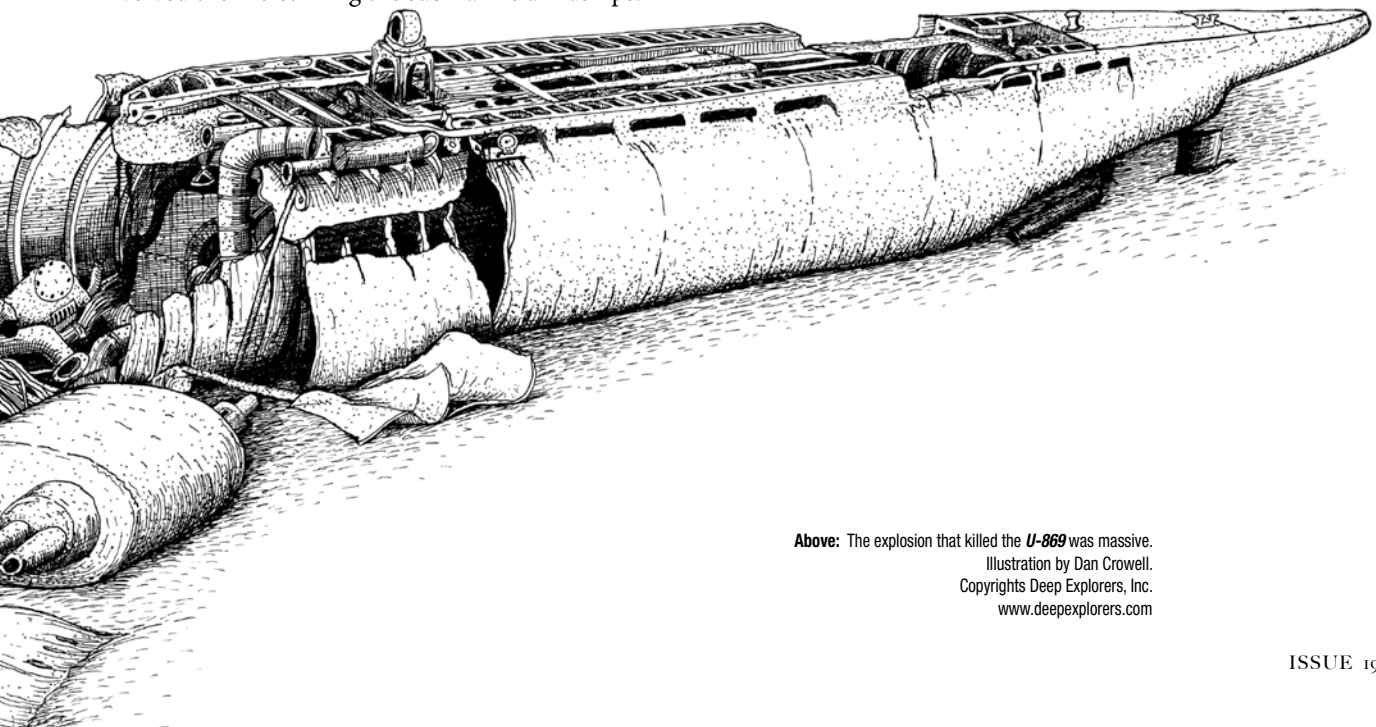
Above: The explosion that killed the *U-869* was massive.
Illustration by Dan Crowell.
Copyrights Deep Explorers, Inc.
www.deepexplorers.com

In a matter of milliseconds, the weapon did exactly what it was designed to do. The shape of the charge helped it cut into the pressure hull of the submarine, leading the explosive train inside the hull. This was aided by the placement of the fusing, which was at the aft end of the explosive warhead, as opposed to the front. This caused the explosive to burn towards the target, supplying even greater penetrating power. **Although the detonation of the torpedo began outside the pressure hull, it continued on into the middle of the Control Room.**

The torpedo triggered a huge concussive wave that blew all of the exterior hatches, and killed the crew instantly. This created the damage in the Control Room that appears to be from an internal explosion, because it actually was. A large amount of oil and floating debris escaped from the ruptured pressure hull, but dispersed in the Atlantic unnoticed at the time.

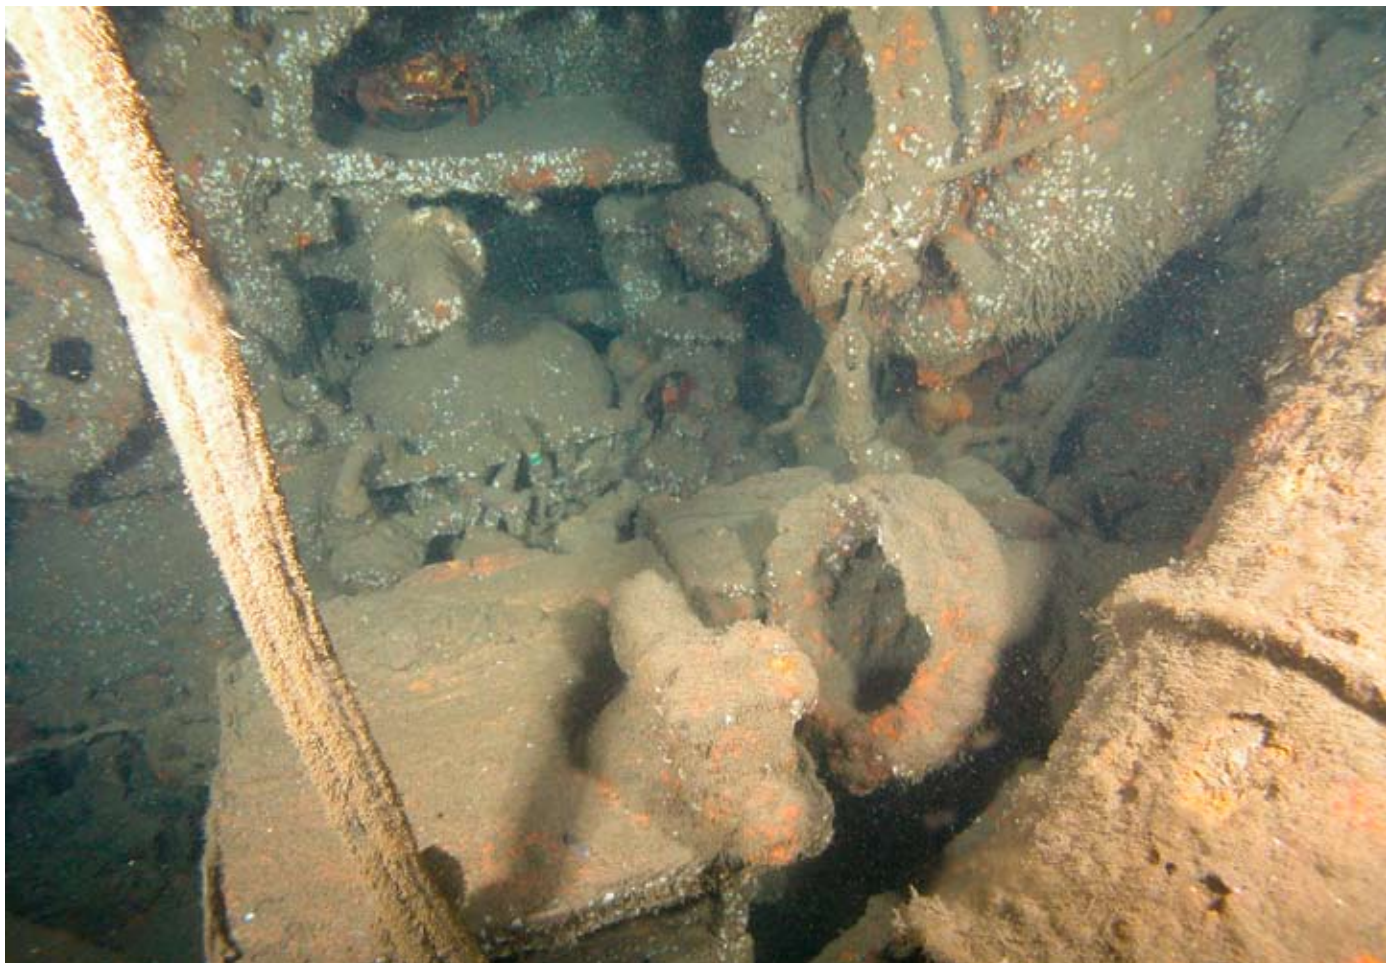
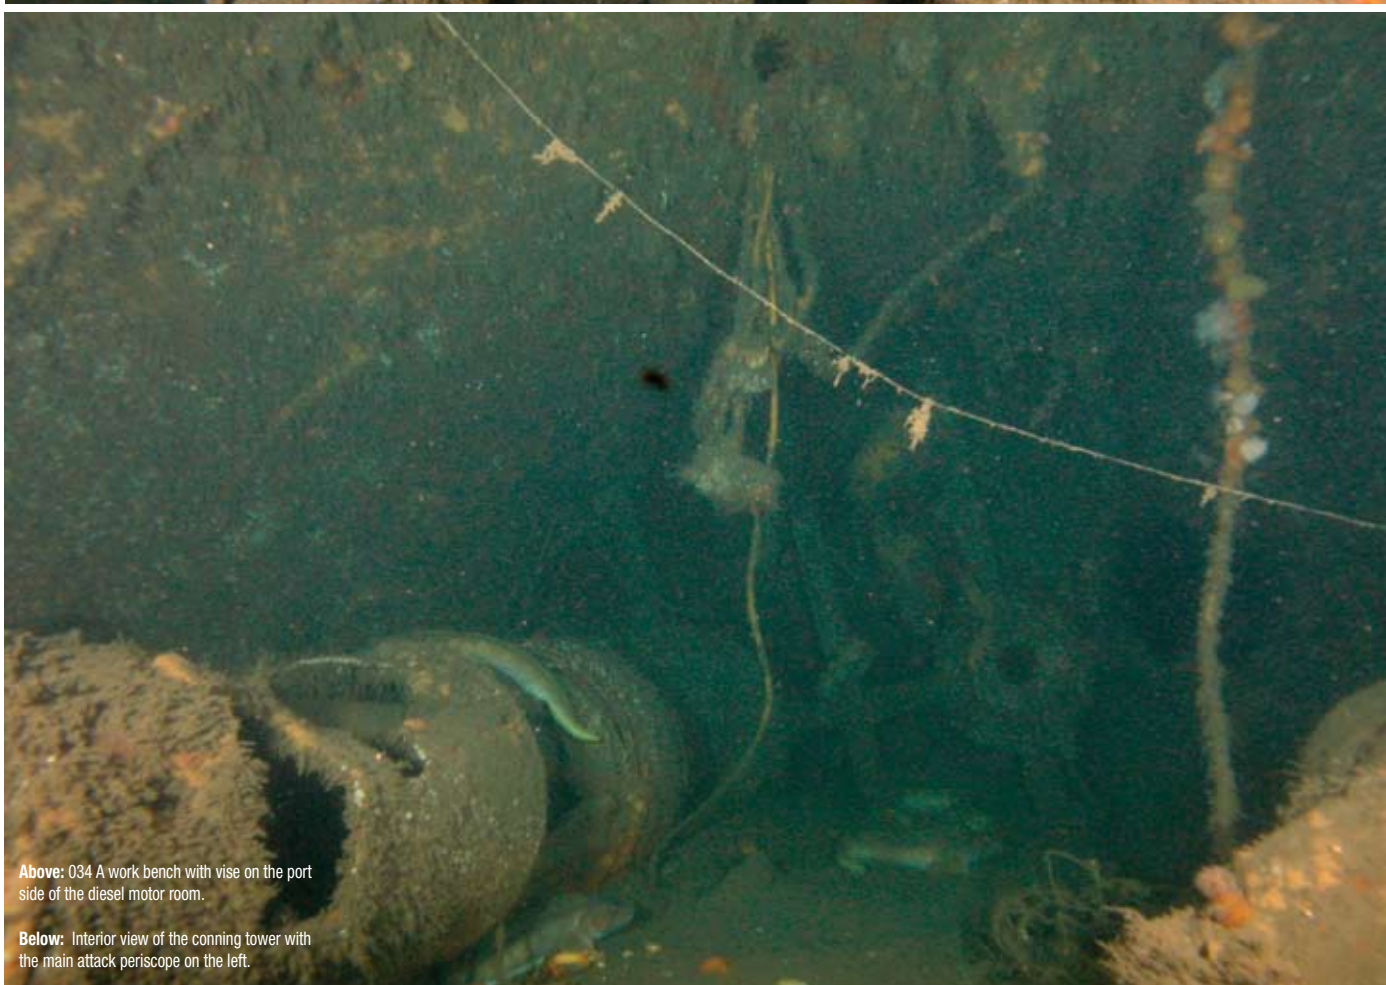
Above: 034 A work bench with vise on the port side of the diesel motor room.

Below: Interior view of the conning tower with the main attack periscope on the left.

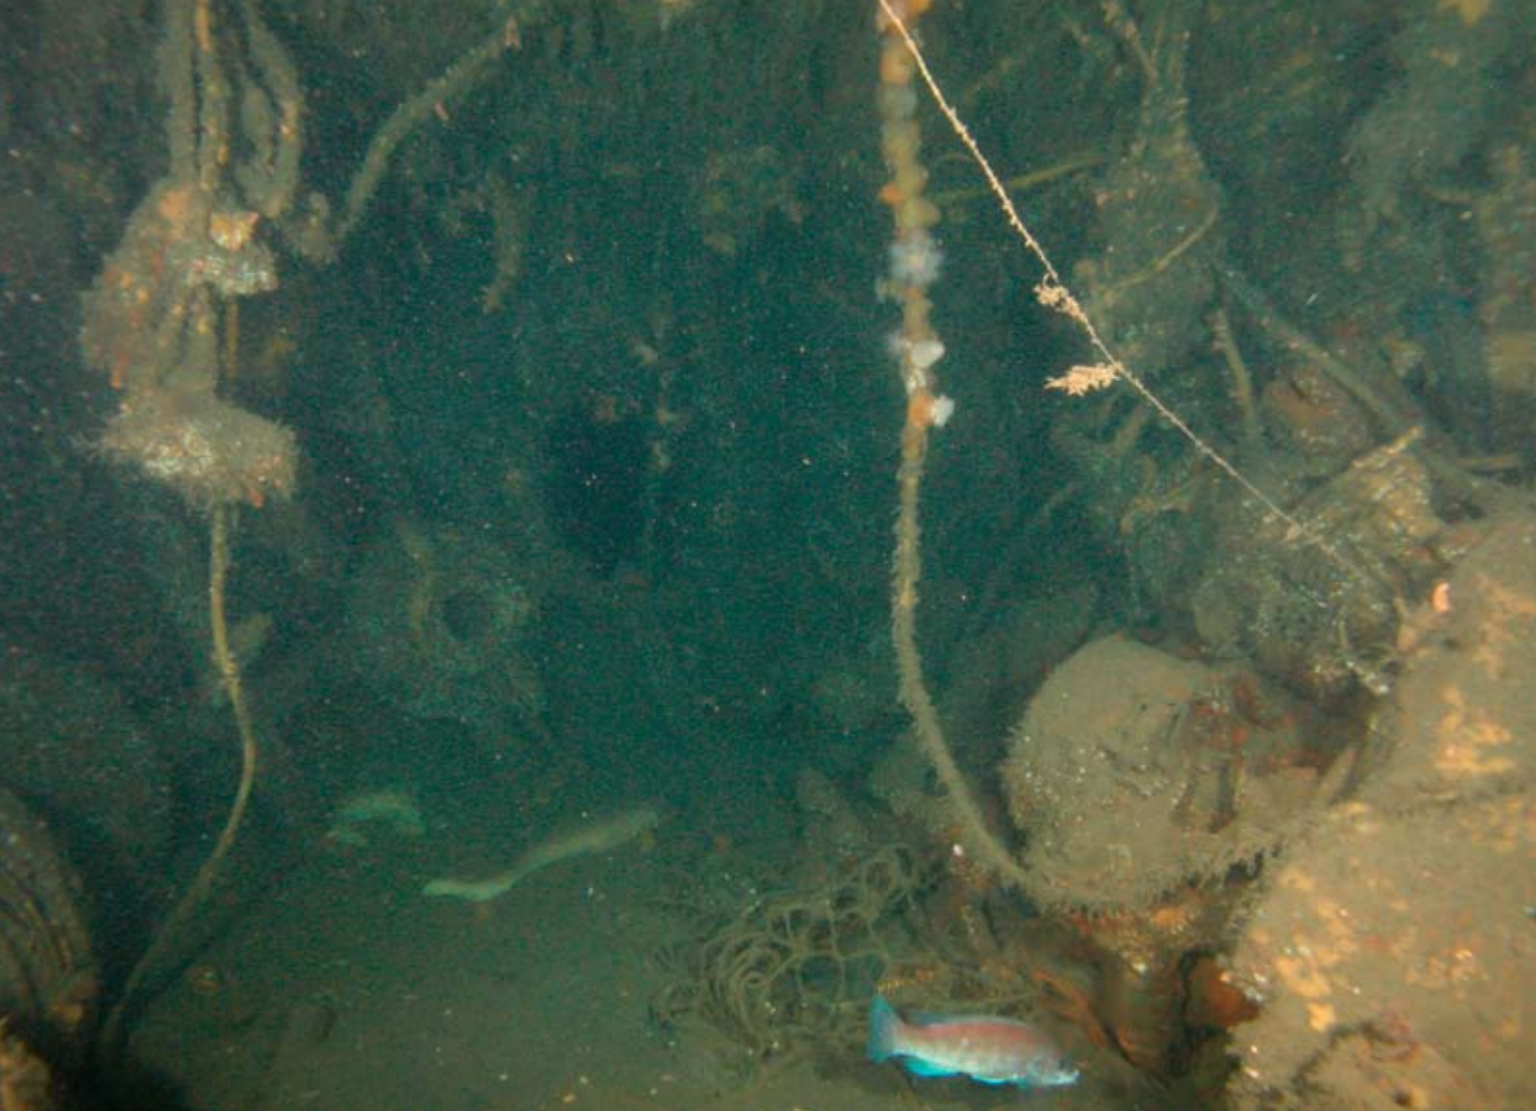
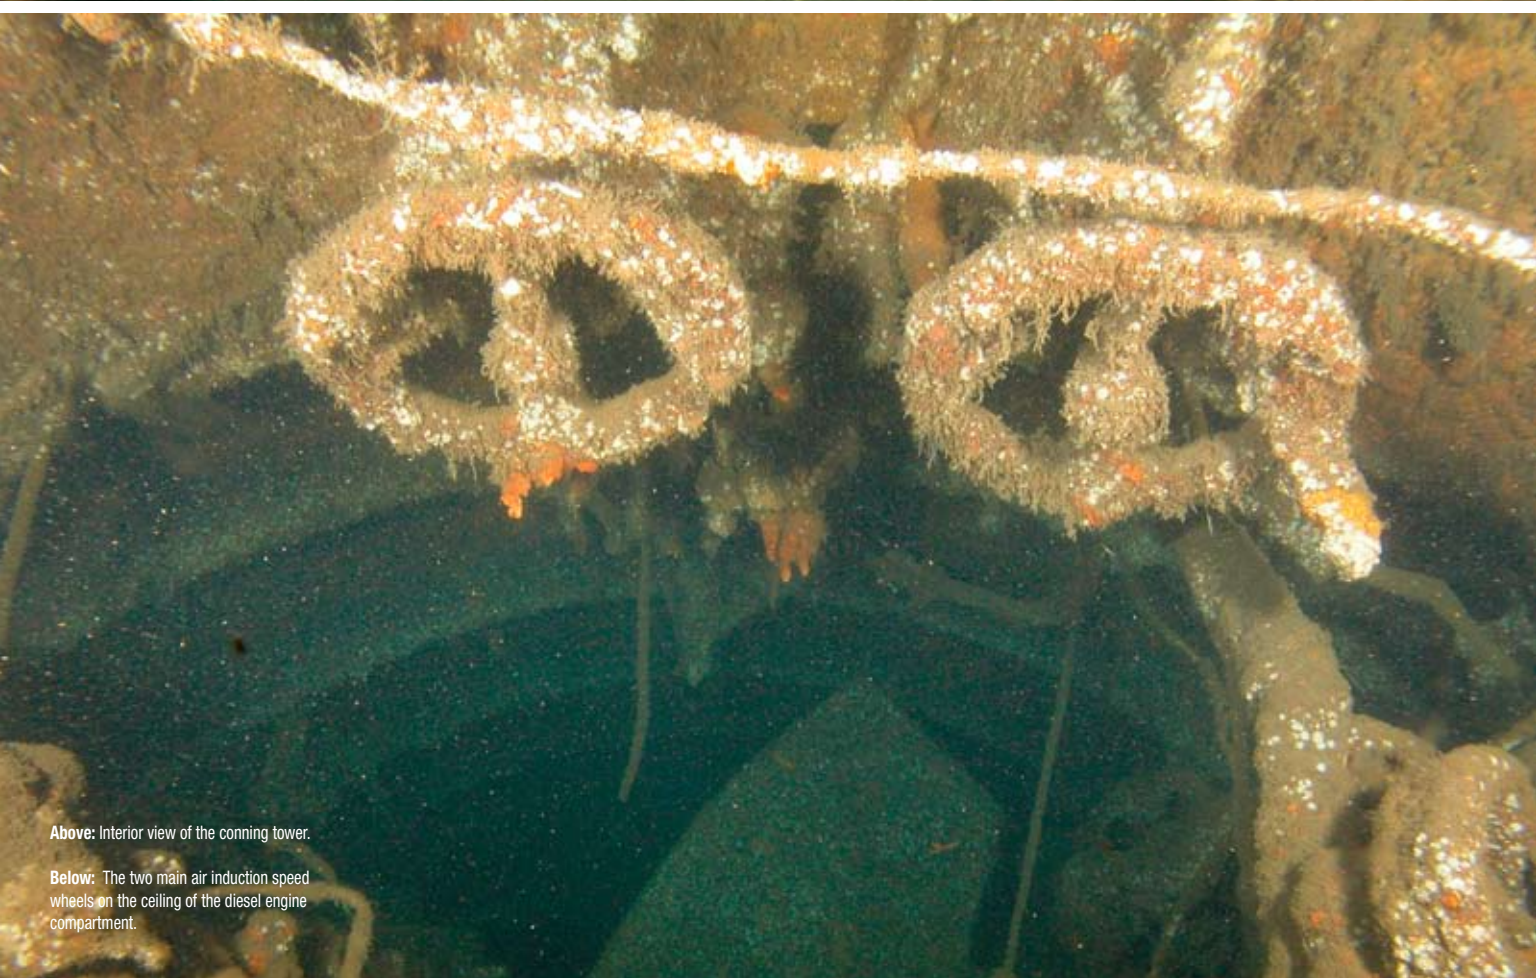
Above: Interior view of the conning tower.

Below: The two main air induction speed wheels on the ceiling of the diesel engine compartment.
